Heavy Ion SEE Test Report for the Samsung 4Gbit NAND Flash Memory for MMS

Test Date: 23 May 2009

Report Date: 18 June 2009

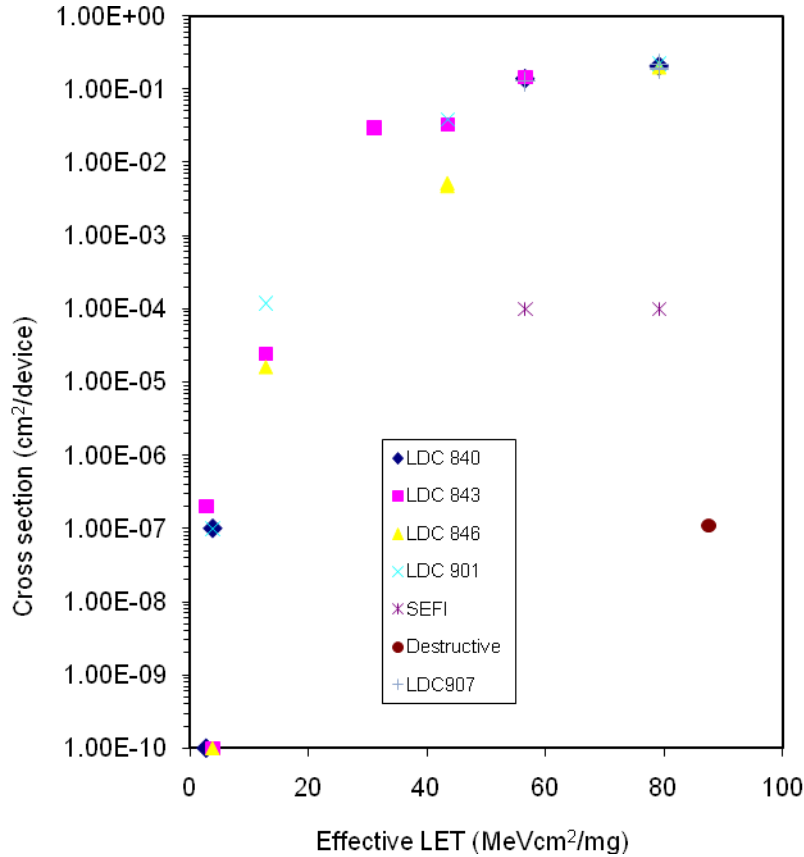
Fig. 4. SEU, SEFI, and Destructive results in static, unbiased test mode.

Fig. 4 shows new results in the unbiased static mode for LDC 907, and also for LDC 840 with Xe ions, both for normal and high angle incidence. LDC 907 had not been tested at all previously, and LDC 840 had been tested only at very high and very low LET, with Au ions and Ne ions ($LET = 2.8$, and 87). For Xe, $LET = 56$ at normal incidence, and $LET_{eff} = 79$ at 45° , which adds two intermediate points for LDC 840. LDC 907 was only tested with Xe. The results in Fig. 4 for these two LDCs are virtually identical, and there is very little difference between any of the LDCs in this test mode, at any LET. The one destructive event occurred with Au ion, ($LET = 87$). The results using the two different orientations, 45° E and 45° N, were that the total cross sections were essentially the same. For this reason, we did most of the high angle exposures in the 45° E orientation, which was easier to align. However, when we did the post-processing of the output files after the run was over, and examined the bit error maps in detail, there was a difference in the error signature. When the beam came from the “North”, there were often pairs of errors, where the same column address would have the same bit in error in two successive pages within a block, for example. Or successive pages would have errors differing by two columns, with the same bit in error at both addresses. Apparently, having the beam incident along the columns causes more of these errors than when the beam angle is across the columns.

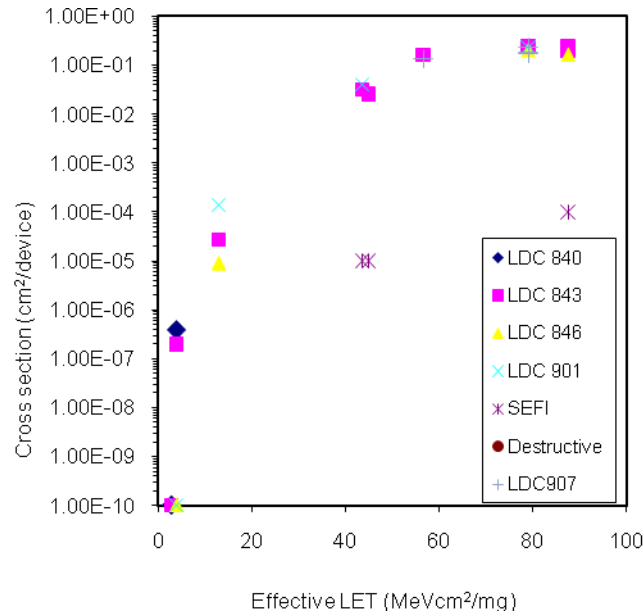
Fig. 5. SEU, SEFI, and Destructive results for static mode, with bias applied.

The results for static mode with bias applied are shown in Fig. 5. The main effect is single bit upsets, along with a few SEFIs, but no destructive events. Again, the results for LDC 840 and LDC 907 are very consistent, with each other, and with the other LDCs. They are also very consistent with the unbiased results in Fig 4, except for the one destructive event with Au ions. In both Figs. 4 and 5, only one shot was at high temperature, 70° C, with Xe ions at 45°, in both cases. There were no SEFIs, no destructive events, and the bit error rate was consistent with shots under other test conditions.

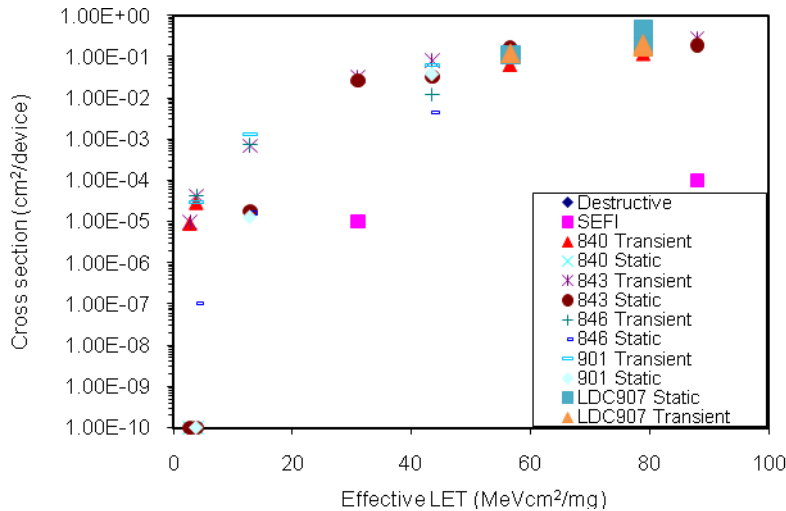
For the Dynamic Read condition, the parts showed exhibited transient read errors in addition to the bit errors, which are plotted in Fig. 6. In this mode, the DUT reads continuously with the beam on. The significance of the transient errors is not always completely clear, because the entire memory can be read multiple times, which means static errors will be read multiple times. In addition there are errors due to transient noise in the read circuit or the control logic. The static errors are bit errors read after the beam is turned off. In this test mode, there were two SEFIs and no destructive events. The bit error cross-section is similar for all five LDCs. Again, there was only one high temperature shot in this test mode, for LDC 907, with Xe at 45 degrees. There was no SEFI, and the bit error cross-section was consistent with the other shots.

Fig. 6. SEU,SEFI, and Destructive results for Dynamic Read mode.

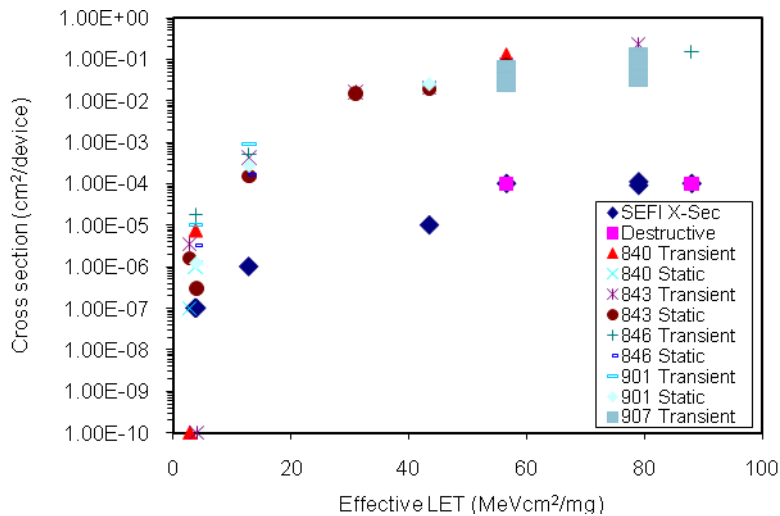
Fig. 7. SEU, SEFI, and Destructive results in the dynamic R/W mode.

Results of the dynamic R/W tests are shown in Fig. 7. Generally these results are unremarkable, because the usual zero-to-one errors are rewritten as they occur. For this reason, there are fewer errors indicated than in Fig. 6, although the difference is not large. The main reason for including this test was the expectation that the high voltage write operation would contribute to more errors in the control circuits, which appears to have happened—there are seven SEFI events, and two destructive failures. One of these was an erase failure with Au, and was previously reported. The other destructive failure, a write mode failure for LDC 840, occurred at normal incidence and room temperature. Where a static cross section is given, it is based on the number of errors detected after the exposure and resetting of the DUT, as before. The transient cross section is based on errors detected during the exposure. But some of the transient errors are probably really static bit errors that were rewritten during the test. The SEFIs were cases where the DUT stopped responding to commands, until power was cycled, or there

were large numbers of non-random errors. In each case except the two destructive events, the DUT was restored to normal operation and used for the next shot. There were nine shots at elevated temperature in this test mode, all but one at 45°, and no destructive failures. These will be discussed in more detail later.

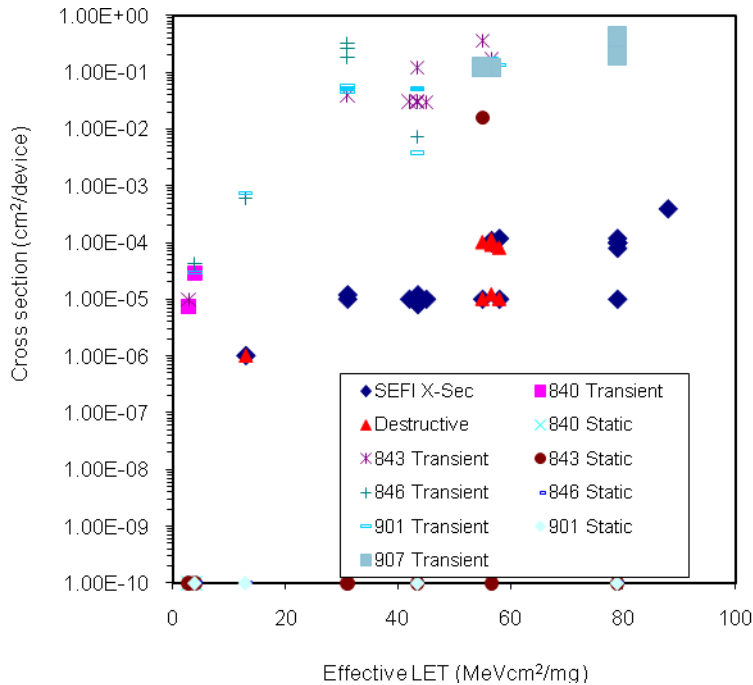
Results for the dynamic R/E/W tests are shown in Fig 8. In this mode, errors are counted as they are read, but then they are erased and rewritten. Therefore, there are no static errors read after the beam is turned off, and bits in error for a time are counted as transient errors. Because the high voltage erase and program operations are performed constantly, it is expected there will be errors in the control logic in this mode. In fact, there were three SEFIs and two destructive failures at room temperature in this mode, and many more at high temperature. In the earlier March test, one SEFI and one destructive event occurred with Ar ions incident at 45 degrees (LDC 0843). Immediately after the shot, the DUT did not respond to commands. After power was cycled, the part responded to commands, except that the write circuit had failed. With Au ions at normal incidence, there was also a SEFI with a destructive failure (LDC 901), also in the March test. This shot was counted as a SEFI because of multiple block errors, but the erase circuit also failed. In the May test, there were 55 shots in this test mode, with all but five at elevated temperature. These are included with the room temperature results in Fig 8. There were six destructive events at high temperature, which were all write failures. Room temperature failures, on the other hand, are usually erase failures. In Table II, we summarize all the destructive events, most of which were at high temperature.

Fig. 8. SEU, SEFI, and Destructive results in Dynamic Read/Erase/Write mode.

In addition to the room temperature results shown in Fig. 8, there were four shots at elevated temperature (70° C) and increased voltage (3.6 V) to test for SEL, in the March test. All were using the R/E/W test mode, with Xe ions incident. In one shot, the ions were at 45° incidence, and the DUT survived at a fluence of 10^5 particles/cm². A SEFI was recorded, but after power cycling, the DUT was successfully reprogrammed. In this case, the DUT was from LDC 901. In three other shots at normal incidence, the DUTs all suffered write circuit failures at lower fluences (LDC 0901 and two parts from LDC 0840). For every shot, the power supply current was monitored continuously, and it is clear from the current traces when these failures occurred. The current traces typically show a read current of about 10-11 mA, with pulses up to 15-16 mA when errors are being rewritten. When the write circuit starts to degrade, the write current will increase, but parts with current in the range of 22-23 mA, or even higher, have still functioned properly. On these shots, the current suddenly increased from 22-23 mA to 30 mA, then 40, then 50 mA, or more, which meant the part had failed. This high current was not the result of SEL, because current returned to normal when the DUT was told to stop writing—no power cycle was
